# Transition Plan

*for the*  
University of Washington - Seattle Campus

October 2020

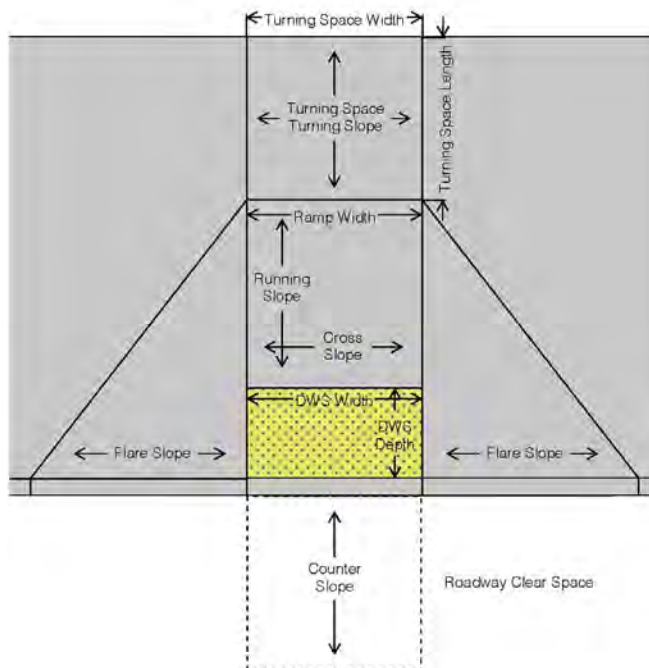
Figure 2-2 Perpendicular Curb Ramp Attributes

Figures 2-2 and 2-3 show the major components of a typical perpendicular and parallel curb ramp, respectively. Eighty-nine percent of the curb ramp locations identified are either non-compliant or missing. The data surveyed for verifying curb ramp compliance was divided into two overarching categories: non-

- The ramp running slope is too steep. 148 curb ramps were found to have a running slope greater than 8.3%.
- Ramp cross slope is too steep. 110 curb ramps have a cross slope greater than 2%, 61 of which are greater than 3%.
- Curb ramp is missing. 158 locations were found to have no curb ramps.

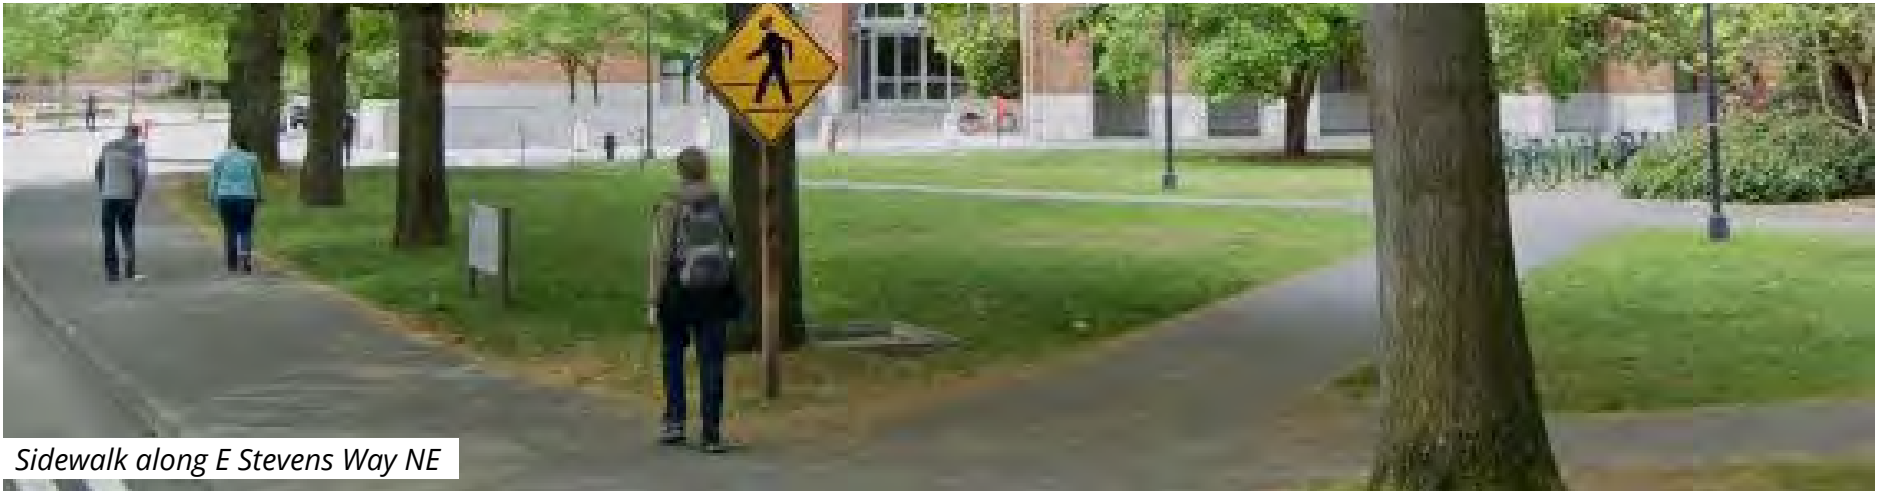
*Sidewalk along E Stevens Way NE*

Several miles of sidewalks and pathways on campus are non-compliant with varying levels of access along the segments. Common attributes for sidewalks and driveways are shown in Figure 2-4. Sidewalk segments that earned an accessibility score of 16-30 were categorized as non-compliant. Sidewalks that received an accessibility score of 1-15 were considered minor non-compliant. See Section 5.2.1 for details on accessibility scores. The most common hazards along the pathways were gaps between concrete panels, uplifted sidewalks panels, and utility boxes without

non-slip coatings. Gaps between panels often come from concrete shrinkage and wear on gap sealant. Non-compliance is primarily attributable to:

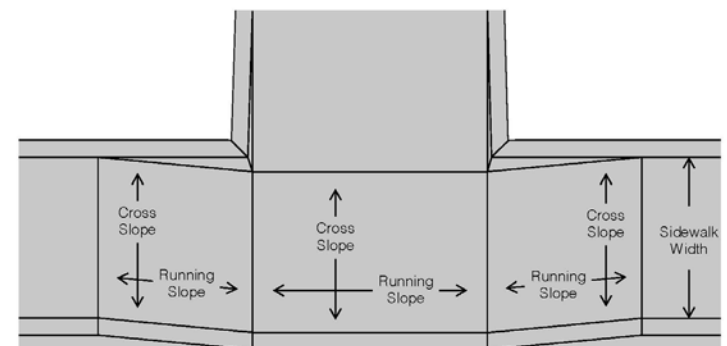
*Figure 2-4 Driveway and Sidewalk Attributes*

- The sidewalk width is too narrow. 0.8 miles of on-site pathways have a width less than 36 inches. 1.7 miles of pathways within the rights-of-way have widths less than 60 inches and have no pullouts. Some of these pathways have alternate routes and can be noted as such during the barrier removal process. 0.3 miles of sidewalks that have non-compliant widths received combined priority scores in the 'highest' priority category.

- The cross slope of the sidewalk is too steep. Around two-thirds of sidewalk segments were found to have at least one location where the cross slope was greater than 2%.

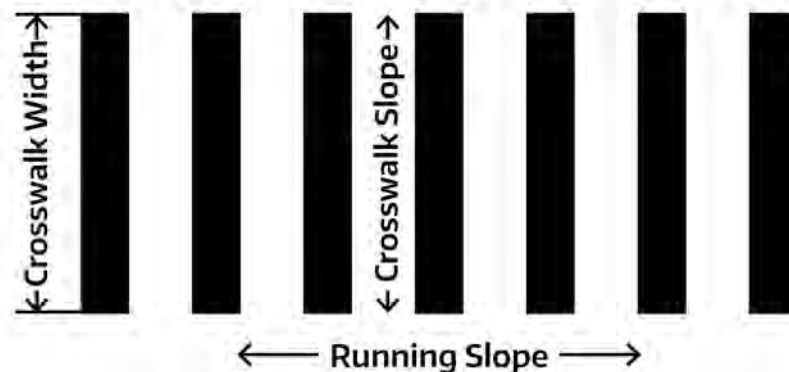
*Figure 2-5 Crosswalk Attributes*

standard width requirement and 83% of all the crosswalks have compliant running slopes. The most common non-compliant element of crosswalks was the cross slope with 31% of crosswalks having non-compliant cross slopes. Per PROWAG, crosswalks at mid-block crossings can have cross slopes that match the grade of the road they are crossing, while crosswalks with stop or yield control are required to have a cross slope less than or equal to 2%. At intersections without stop or yield control, acceptable cross slope can be a maximum of 5%. The number of compliant crosswalk cross slopes takes into account these location subtleties. Figure 2-5 shows the major attributes measured for crosswalks.

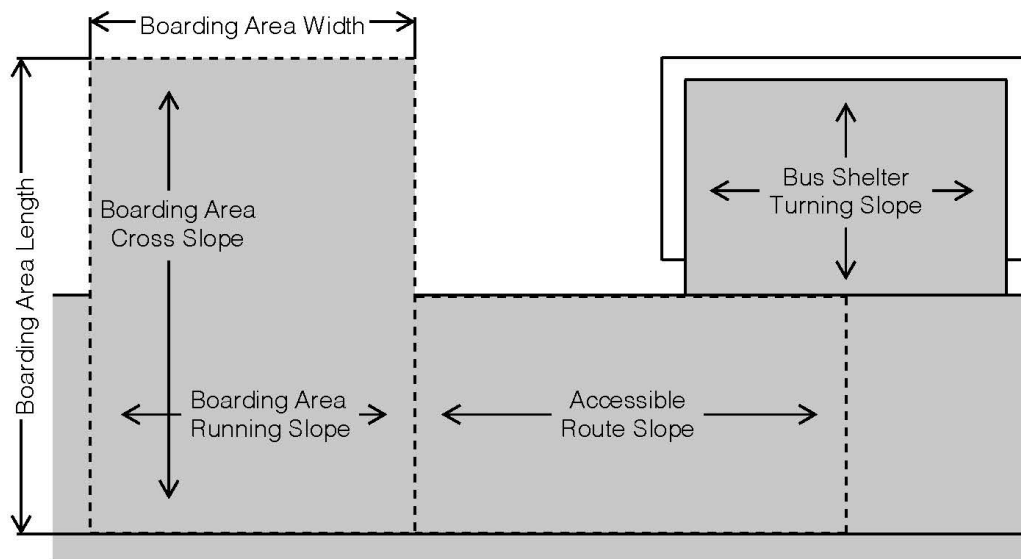
Figure 2-6 Bus Stop Attributes

Features of boarding area dimensions and slopes, accessible routes and turning spaces are covered in ADA standards for bus stops and shown on Figure 2-6. These were measured for 16 bus stops on University property. All but two of the measured boarding areas met the required 5X8 feet size which allows for the use of chair lifts on buses. The common non-compliant elements in this area were the boarding area and bus shelter cross slopes.
